AIR ENGINEER

The Journal of the Royal Air Force Air Engineer Branch

1990

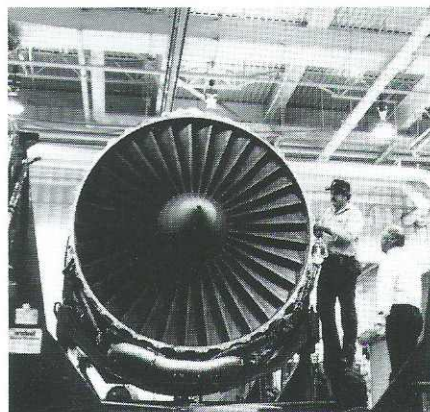
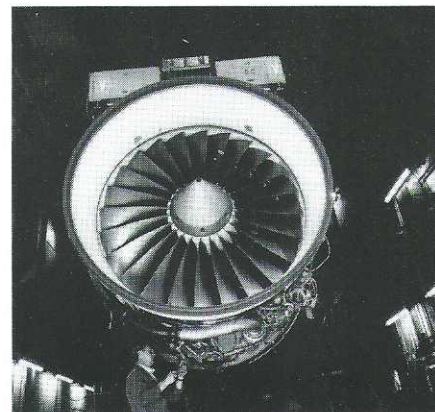
For comparison: the snubbed fan of a RB211-524D4 engine and the more efficient wide-chord fan of a RB211-524G (right)

Previous high bypass fans have, therefore, been universally designed with relatively narrow blades. These are aerodynamically unstable and would flutter and fail rapidly in fatigue if they were not stabilised part-way along their length by projections on the side of each blade known as snubbers (clappers). These are in close proximity when the fan is static and act as a stiffening ring when the fan rotates.

If blade width is increased, blades become stiffer and aerodynamic stability can be achieved without the use of snubbers. The number of blades required depends on their chordal width. As a result, fewer of the wider blades are needed – typically a reduction from 33 to 22 blades for the Rolls-Royce wide-chord fan of the 535E4 engine and to 24 for the fan of the 524G engine.

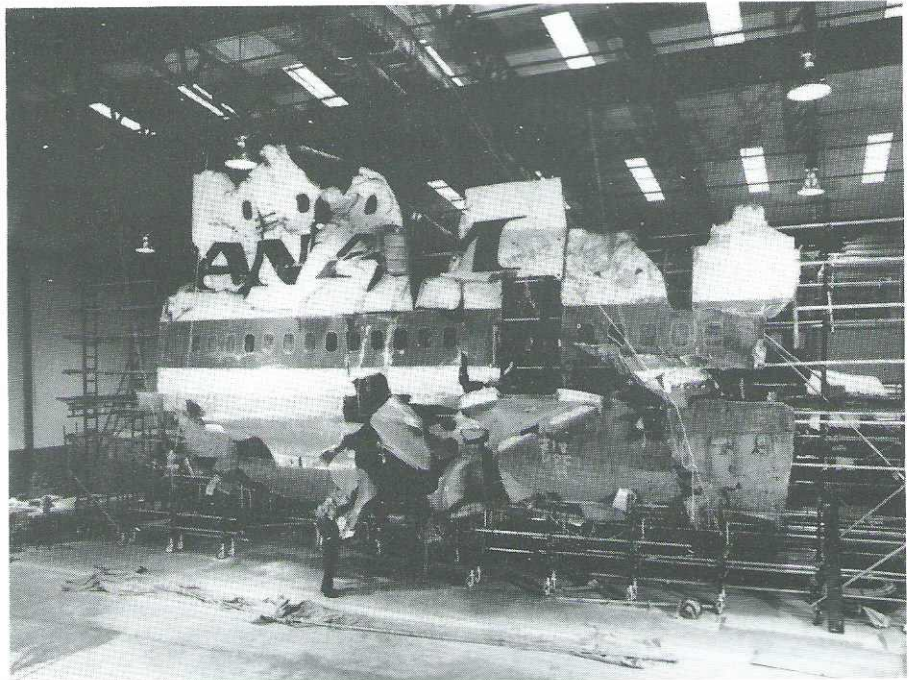
Lower forward port fuselage section reconstructed by AAIB at Farnborough - Pan Am 103.

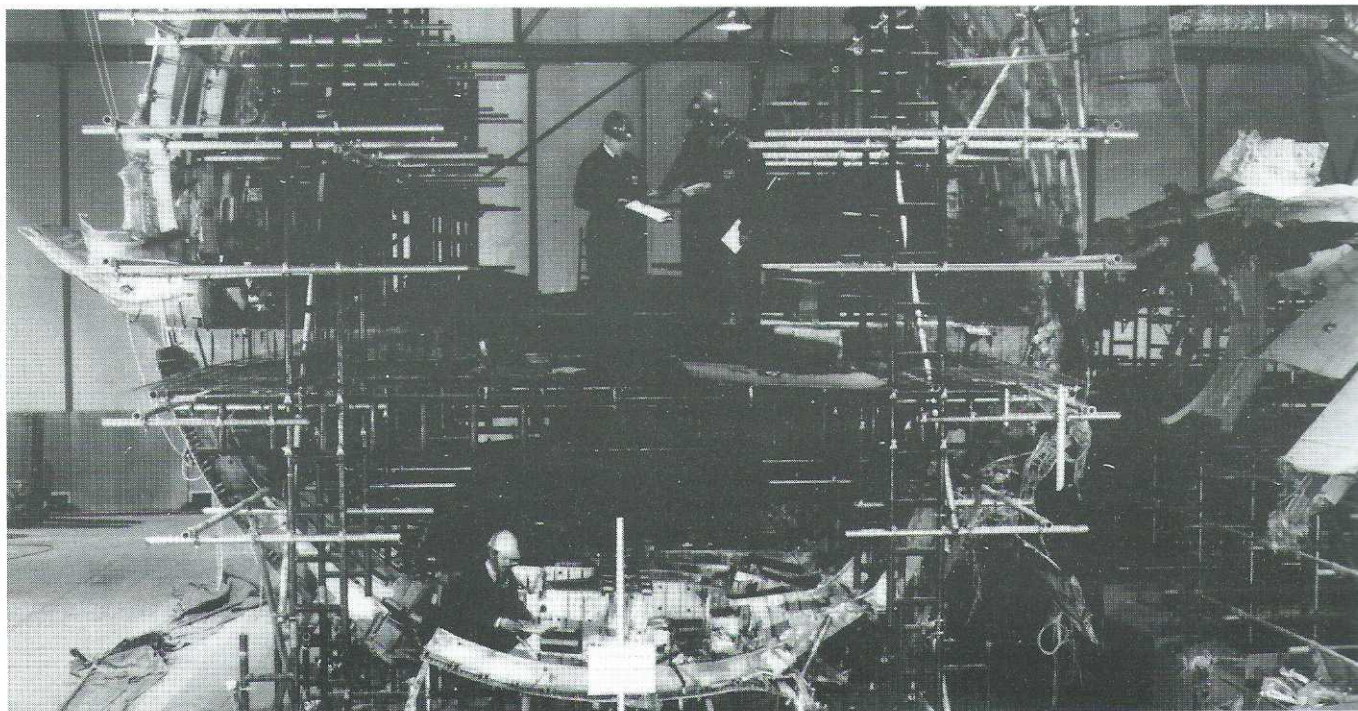
**End section of reconstructed lower fuselage section of Pan Am 103 showing lower cargo hold and three AAIB Inspectors on passenger deck. (Roof section right of photograph.)
Lockerbie Air Disaster Friday 15/12/89**

The hangar floor was painted with a grid corresponding to the aircraft stations so that as soon as items of wreckage arrived and were identified they could be placed on the grid in their correct relative position to other items of structure. Around the edge of the building bays were marked corresponding to geographical search areas so that items not immediately identifiable could be stored until we were able to examine them further. Well in excess of 90 per cent of the aircraft

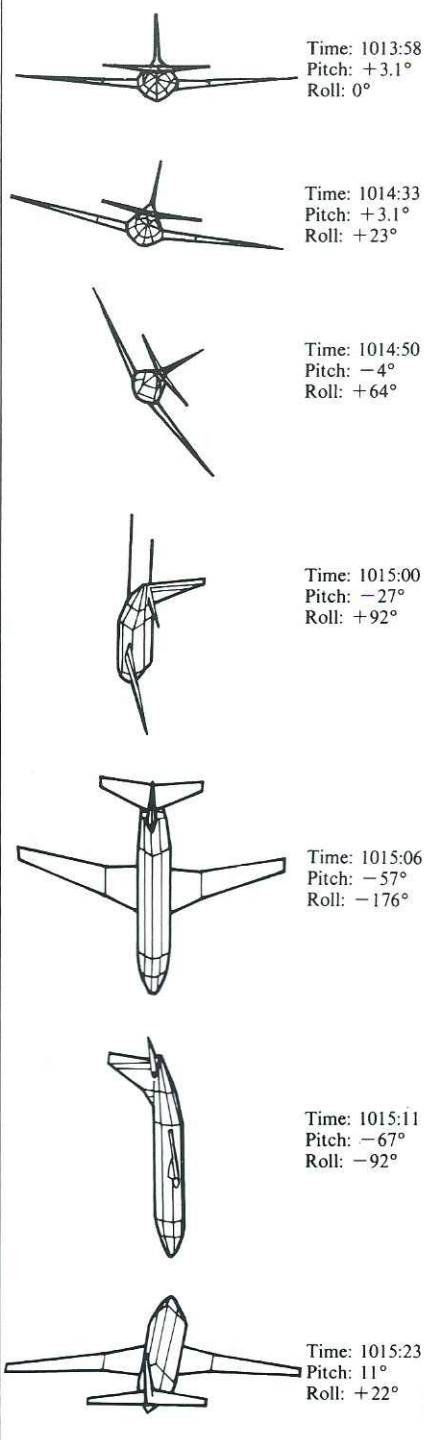
Sequence shows how aircraft descended from about 40,000ft to 30,132ft, during which it completed a 360 degree right-hand roll and then pitched upwards. The 4-5 g forces later prevented the flight data recorder from functioning properly.

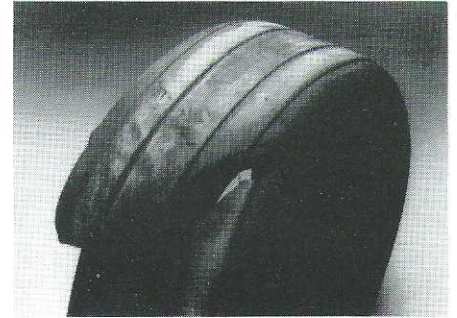
Cut and burst

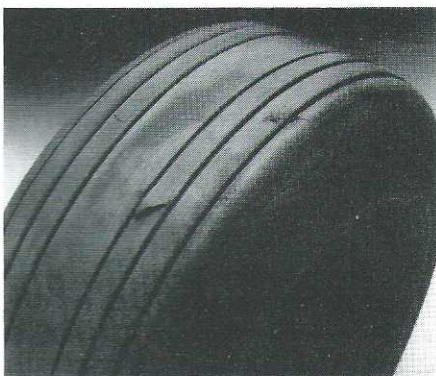
Deep cut

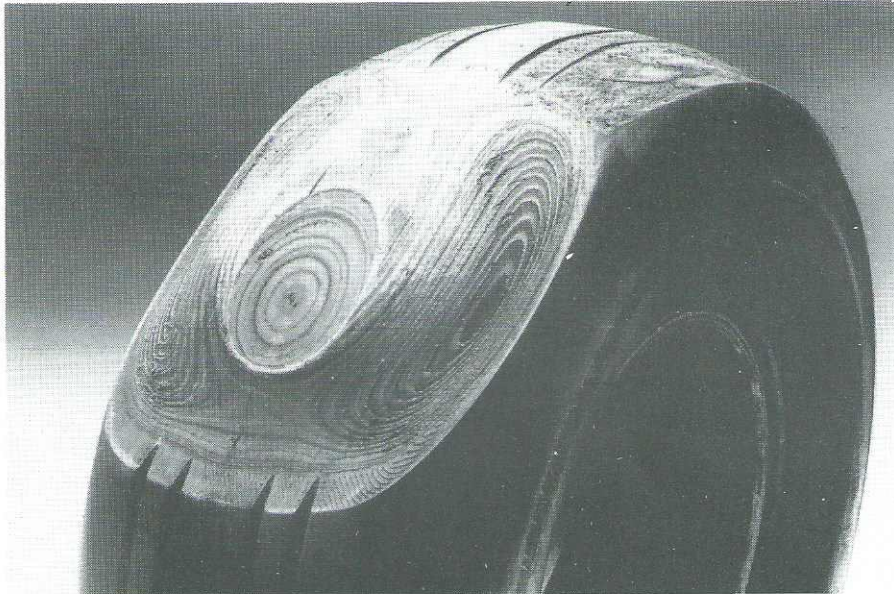
Braking flat – tyre deflated and on a dry runway

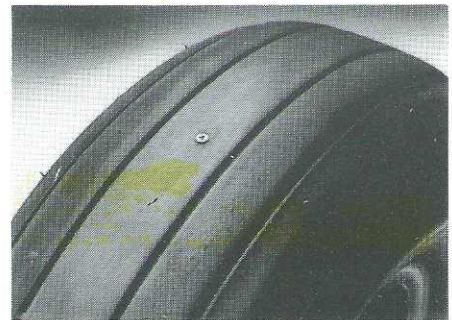
Foreign object in casing
